CCS 技术通告

(2015 年) 技术通告第 30 号总第 191 号

关于自由降落救生艇安全的通告

Free-fall lifeboat safety

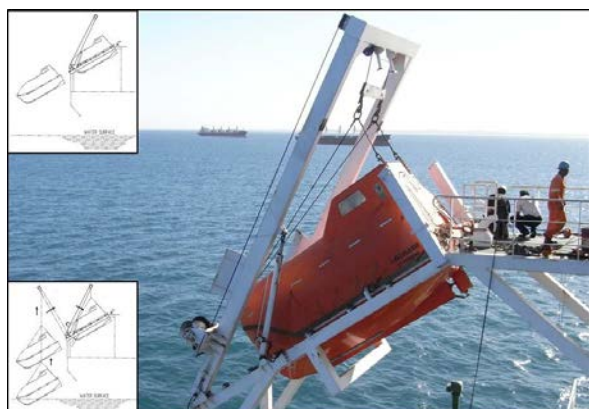
Aquarosa (IMO No. 9506708) - On 1 March 2014, Aquarosa's free-fall lifeboat was inadvertently released during a routine maintenance inspection while the ship was en route to Fremantle, Western Australia. One crew member was injured in the incident and it took 5 hours for the crew to recover the lifeboat.

Aquarosa's Free-fall Lifeboat arrangement

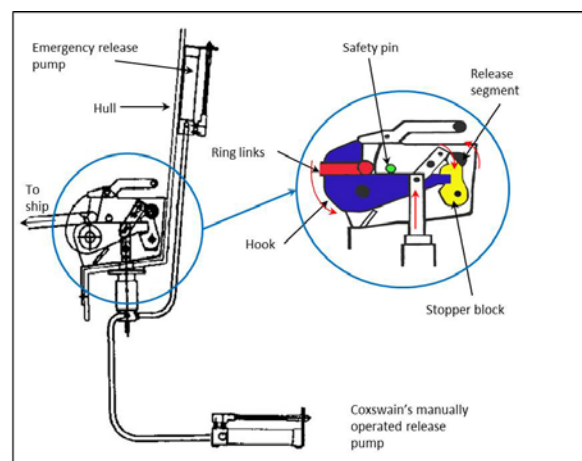
The ATSB identified that the Second Engineer accidentally activated the lifeboat's on-load release mechanism while carrying out a test procedure. When the Second Engineer cycled the hydraulic system, the retaining hook was released allowing the lifeboat to move down the launch ramp.

The ATSB found that the hydrostatic on-load release mechanism hydraulic cylinder ram had not fully retracted after use, preventing the stopper block from resetting correctly. This left the release hook in a partially disengaged position.

The ATSB noted that the design of the release mechanism cover plate prevented visual confirmation that the hook was correctly reset.

Aquarosa's free-fall lifeboat release system

The lifeboat was fitted with simulation wires to prevent it from launching under these circumstances. However, on this occasion, the simulation wires failed allowing the lifeboat to move down the guide rails into the sea. The ATSB found that the simulation wires failed due to a combination of incorrect installation and cumulative internal wear from numerous shock loading events that resulted from previous lifeboat launching drills.

- 1、在每次弃船演习后，应目视检查艇钩及液压油缸、止动块是否完全复位。
- 2、对于护套钢索（模拟释放钢索和吊艇索），建议割去外护套，以便确认内部钢丝状况良好，一旦发现问题，须立即更换。
- 3、船公司应需要及时更换，该钢索应为防旋转钢索并持有船级社船用产品证书。模拟释放钢索长度和连接方式应满足厂家说明书的规定。
- 4、船公司应必要时或按不超过五年间隔期更换吊艇索，该吊艇索应为防旋转钢索并持有船级社船用产品证书。
- 5、船上应建立有效的自由降落救生艇维护保养程序，并且检查该程序能够有效实施。船员应被培训并熟悉维护保养程序以减少他们在实施维护保养工作时的风险。
- 6、船员应严格按照 SOLAS 规定、以及生产厂家的维护保养手册要求，进行自由降落救生艇的日常维护保养与检查。
